Description and analysis of the operation of on-board systems of Tu-154M aircraft No 101

Final Report – Appendix 2. Description and analysis of operation of on-board system of Tu-154M aircraft No 101

DESCRIPTION OF DAMAGE TO THE AIRCRAFT

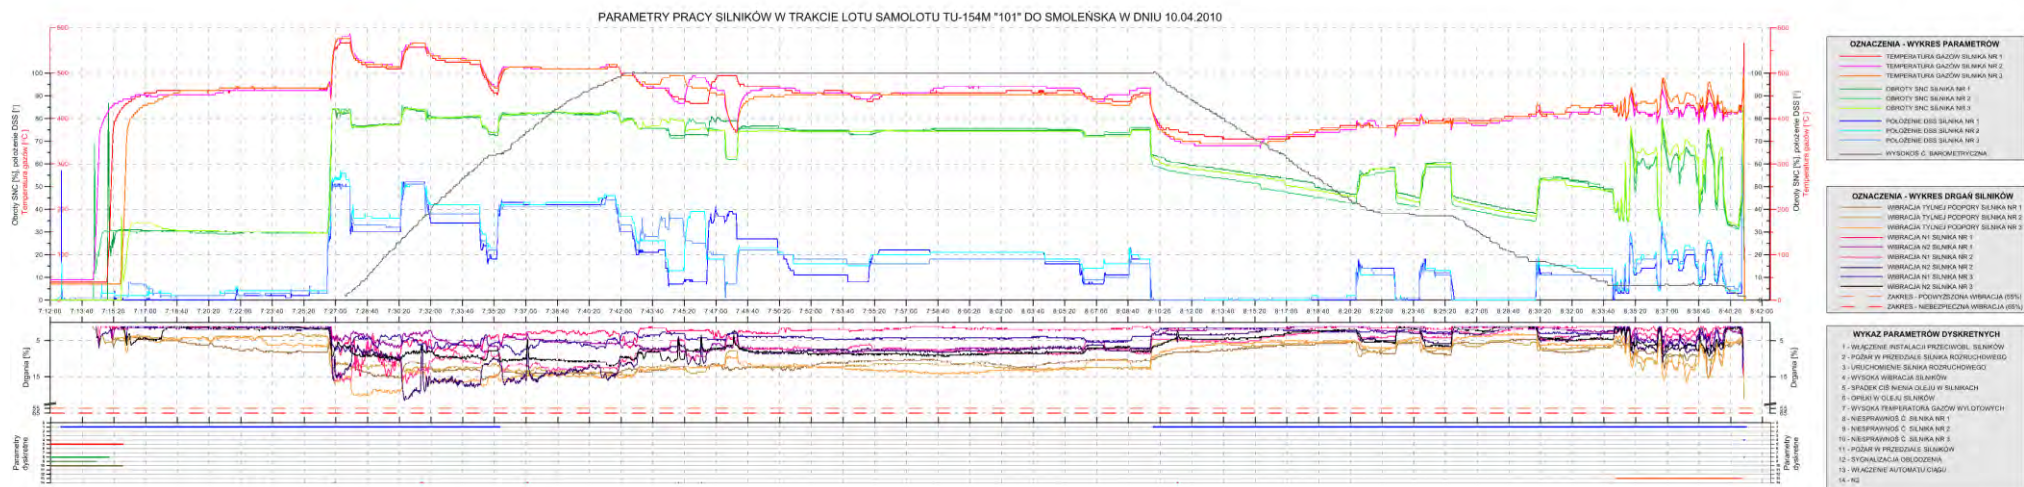
PARAMETRY PRACY SILNIKÓW W TRAKCIE LOTU SAMOLOTU TU-154M „101” DO SMOLEŃSKA W DNIU 10.04.2010	ENGINE OPERATION PARAMETERS DURING TU-154M AIRCRAFT NO 101 FLIGHT TO SMOLENSK ON 10 APR 2010
OZNACZENIA – WYKRES PARAMETRÓW	DESIGNATIONS – PARAMETER CHART
TEMPERATURA GAZÓW SILNIKA NR	ENGINE NO [...] GAS TEMPERATURE
OBROTÓW SNC SILNIKA NR	ENGINE NO [...] SNC SPEED
POŁOŻENIE DSS SILNIKA NR	ENGINE NO [...] THROTTLE LEVER POSITION
WYSOKOŚĆ BAROMETRYCZNA	PRESSURE ALTITUDE
OZNACZENIE – WYKRES DRGAŃ SILNIKÓW	DESIGNATION – ENGINE VIBRATION CHART
WIBRACJA TYLNEJ PODPORY SILNIKA NR	ENGINE NO [...] REAR SUPPORT VIBRATION
WIBRACJA NR [...] SILNIKA NR [...]	VIBRATION NO [...] OF ENGINE NO [...]
ZAKRES – PODWYŻSZONA WIBRACJA	MODE – INCREASED VIBRATION
ZAKRES – NIEBEZPIECZNA WIBRACJA	MODE – DANGEROUS VIBRATION

At 0841:02.9, the speeds of low-pressure power transmissions of engines 1, 2, 3 reached the values of 83.8%, 84.0%, 83.3%, respectively, which roughly corresponds to “nominal” mode. Hence the engines had not managed to reach the takeoff mode. The low-pressure power transmission speeds increased from approximately the idle mode to values roughly corresponding to nominal mode within 7.4 s. The time and manner of engine acceleration testify to their good condition and correct adjustment.

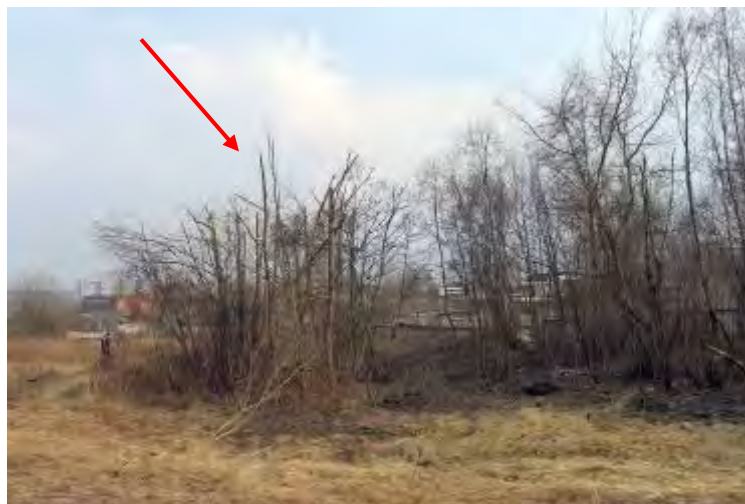
Upon traveling further 18 m, the fuselage and wings collided with trees whose trunk diameter was about **10 cm**. At this moment, the wings were level and the pitch angle increased to aprox. **12°** (fig. 5 and 6). The local trees and bushes were sheared at 4 m above ground. The airplane's position at this point was about 3 m below the runway threshold.

Fig. 5. Trees (item 4 fig. 2) damaged by landing gear and fuselage

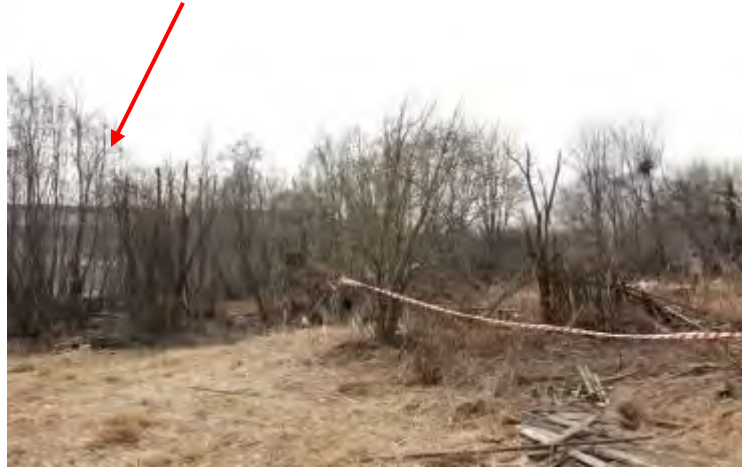
Fig. 6. Trees (item 4 fig. 2) damaged by the tip of the left wing

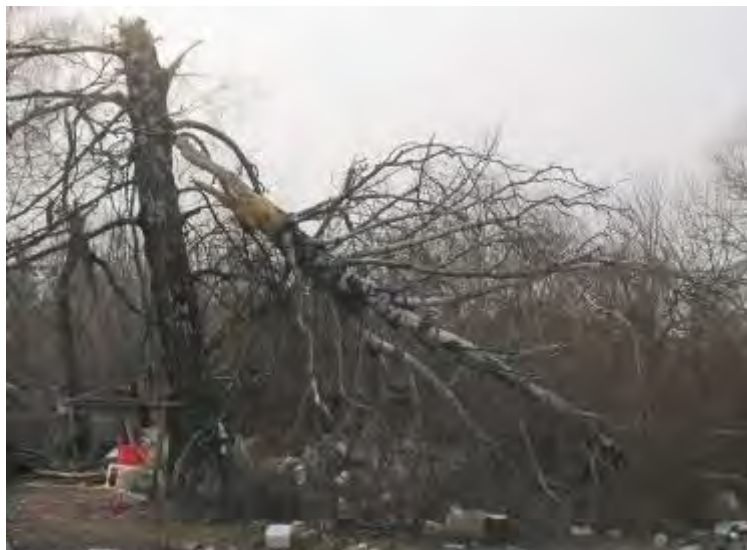
855 m away from the runway threshold, the left wing collided with a large birch tree, about **5.1 m tall** (Fig. 6), which led to the separation of a large (about 6 m) section of the left wing including the aileron. At that point, the center of gravity of the airplane was about **1.1 m** above the runway threshold, roll was about **-2.5°** (left roll), and pitch increased to **12.8°**.

Fig. 7. Birch tree (item 4 fig. 1 item 5 fig. 2) damaged upon collision with the left wing

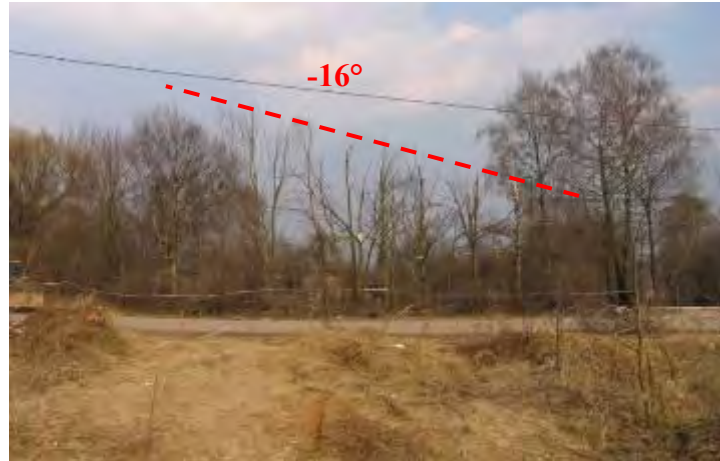
Travelling further **47 m**, the plane continued to collide with trees of limb diameters of up to **15 cm** (Fig. 8) over a distance of **20 m**. Roll increased dramatically and reached approx. **-16°** (left).

Fig. 8. Trees damaged (item 6 fig. 2) by wings and fuselage with roll of approx. -16° (left)

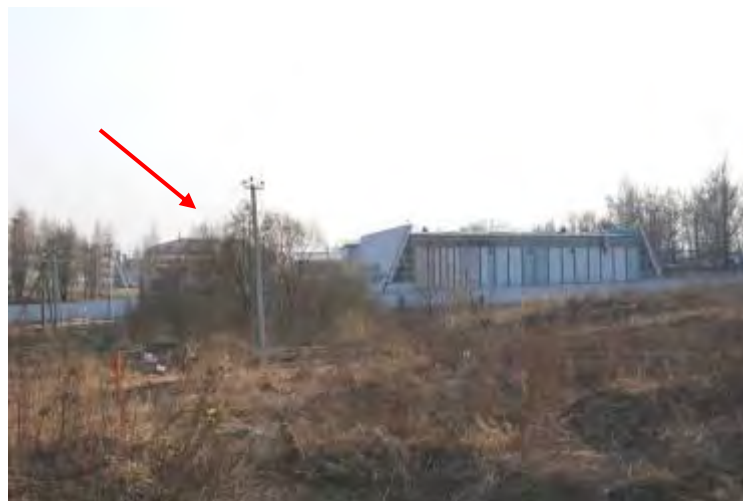
Fig. 9. Severed power cables (item 7 fig. 2)

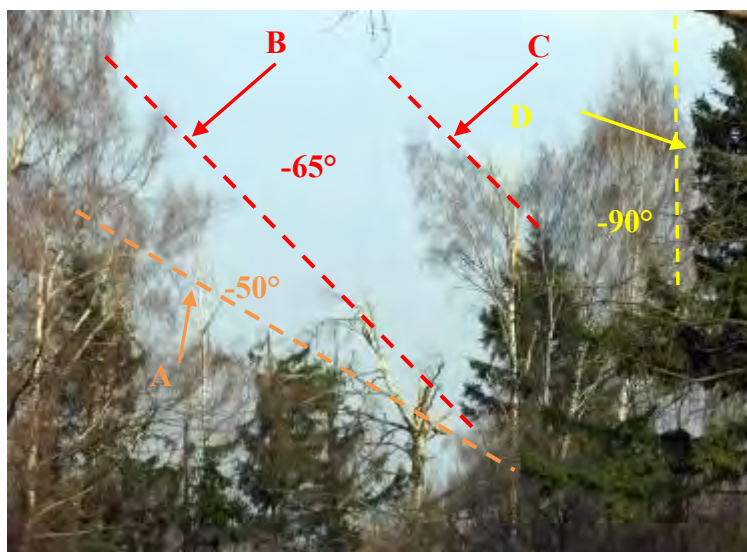
break (Fig. 10) and increasing roll to approx. -90° . Those impacts caused extensive damage to the leading edges and numerous damages to the elevators and rudder surfaces.

Fig. 10. Trees damaged 150 m away (item 8, 9 and 10 fig. 2)
from the point of separation of the left wing:

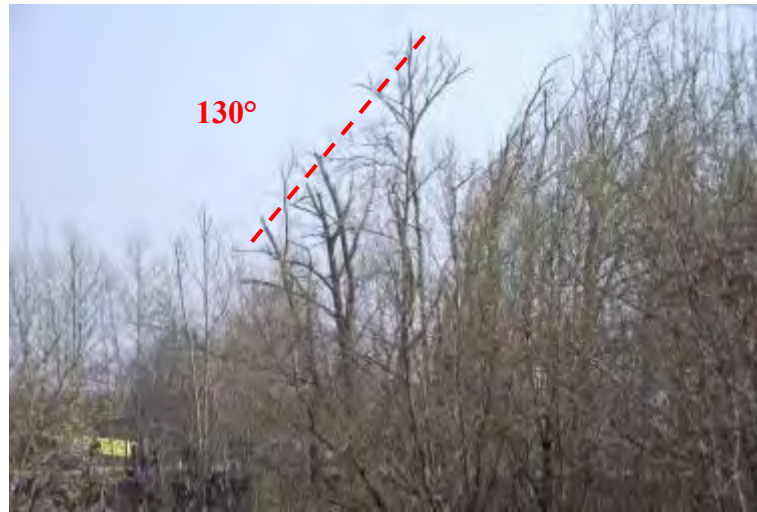
50 m later, the plane's roll increased to -120° as the fuselage, wings, and tailplane impacted with two tall trees causing their limbs and branches to break. At this moment, the left elevator separated. With a roll reaching -130° , the plane collided with the last group of trees. The fuselage pitch was approx. 16° and started decreasing quickly in the following flight phase. That point is marked as '6' in fig.1 and it corresponds with the point where the ATM-QAR flight record broke off. In the final phase of the flight, the plane travelled with its nose pointing slightly down.

Fig. 11. Damage to the last group of trees before the impact with the ground

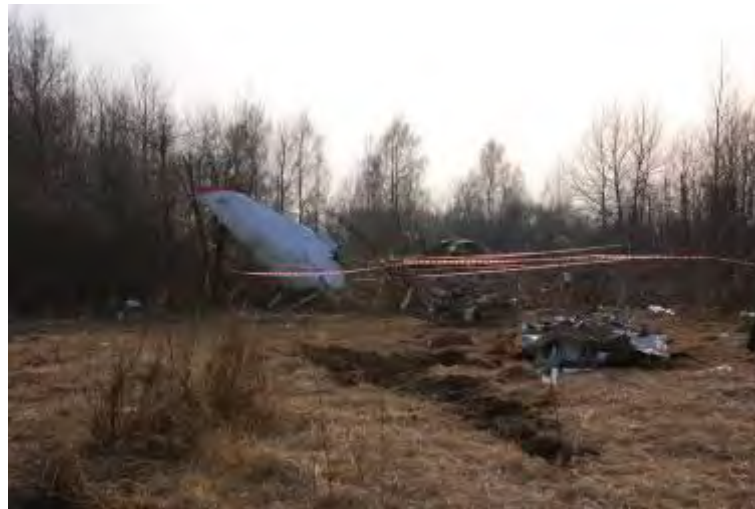
Fig. 12. A furrow left by the left elevator

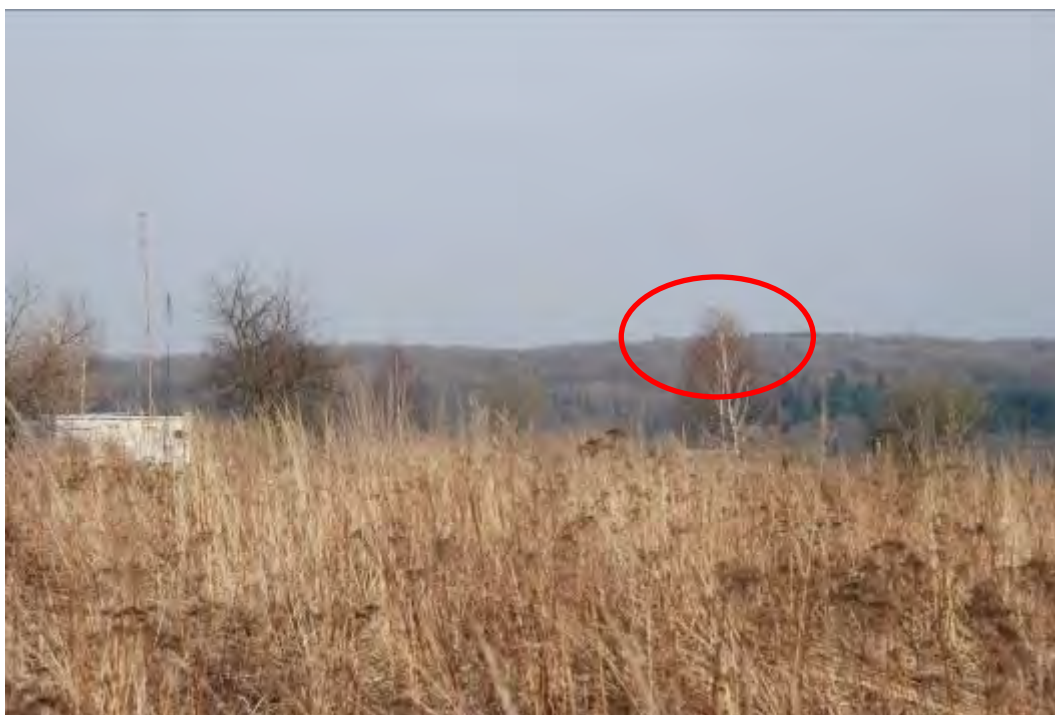
At a distance of about 2.7 km from the runway threshold, the aircraft Tu-154M, tail number 101, appeared below the specified glide path and was continuing its descent. About 30 m before the inner NDB, the aircraft was low enough to come into contact with the first ground obstacle (1,099 m from the runway threshold, about 39 m to the left of its centreline). The tip of the left wing hit the top of a birch tree at a height of about 10 m which resulted in cutting off thin branches of about 1 metre in length (Fig. 1). The collision did not inflict damage affecting the aircraft's ability to fly (probably, only local damage to the paint coat occurred on the wing's leading edge).

Fig. 1. A birch tree with cut-off tips

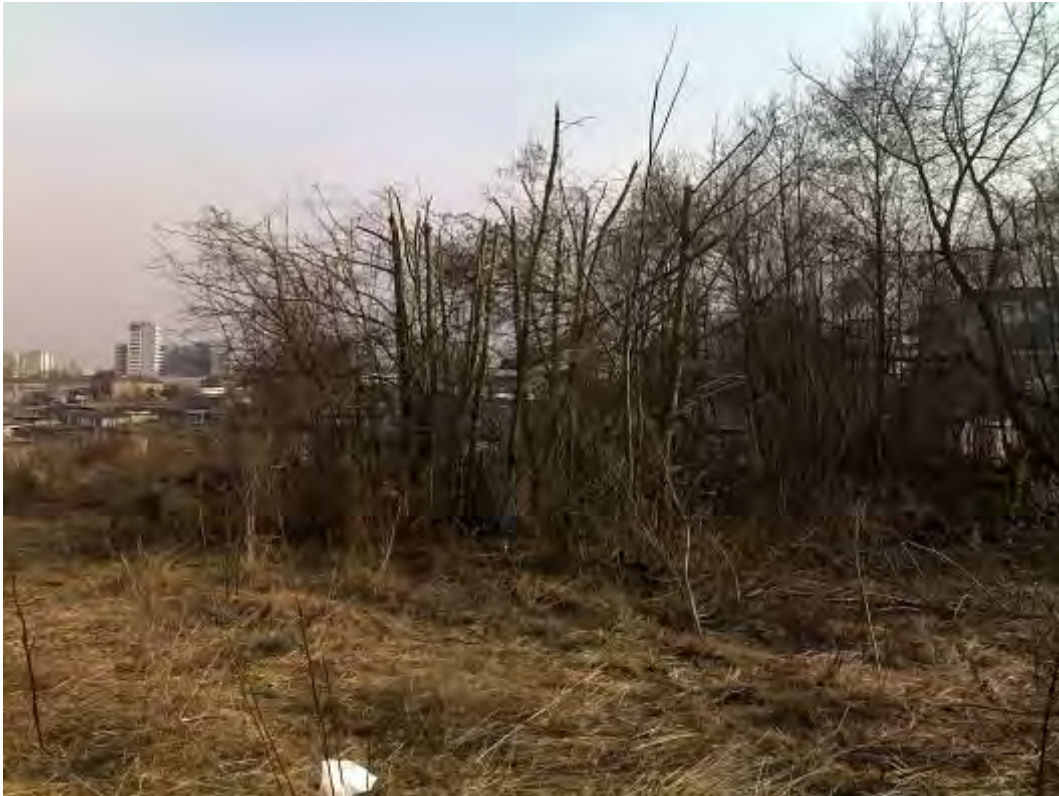
- Two clumps of young birch trees - cropped with the left wing edge;
- A group of young birch, poplar and other trees - branches broken with the aircraft's left wing edge (Fig. 2).

Fig. 2. A group of trees cropped with the left wing

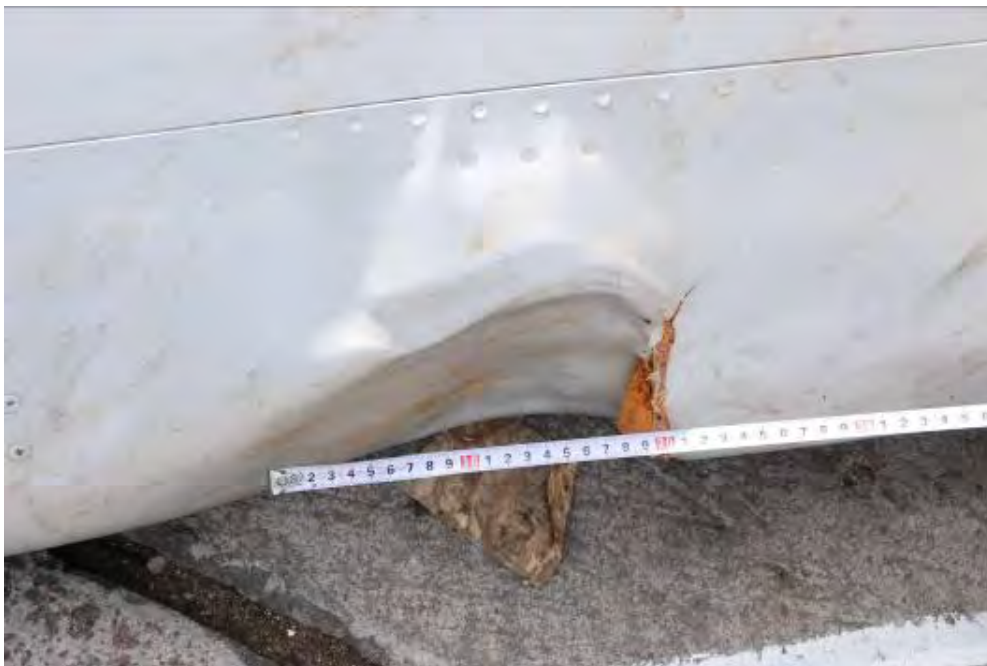
The collisions made characteristic dents in the wing's leading edge and caused deformations and numerous tears both in the lower skin panels of the wings and the displaced flaps (fig. 3). Possibly, this was the moment when wiring harnesses suffered the initial damage.

Fig. 3. Characteristic oval-shaped dents in the wing's leading edge

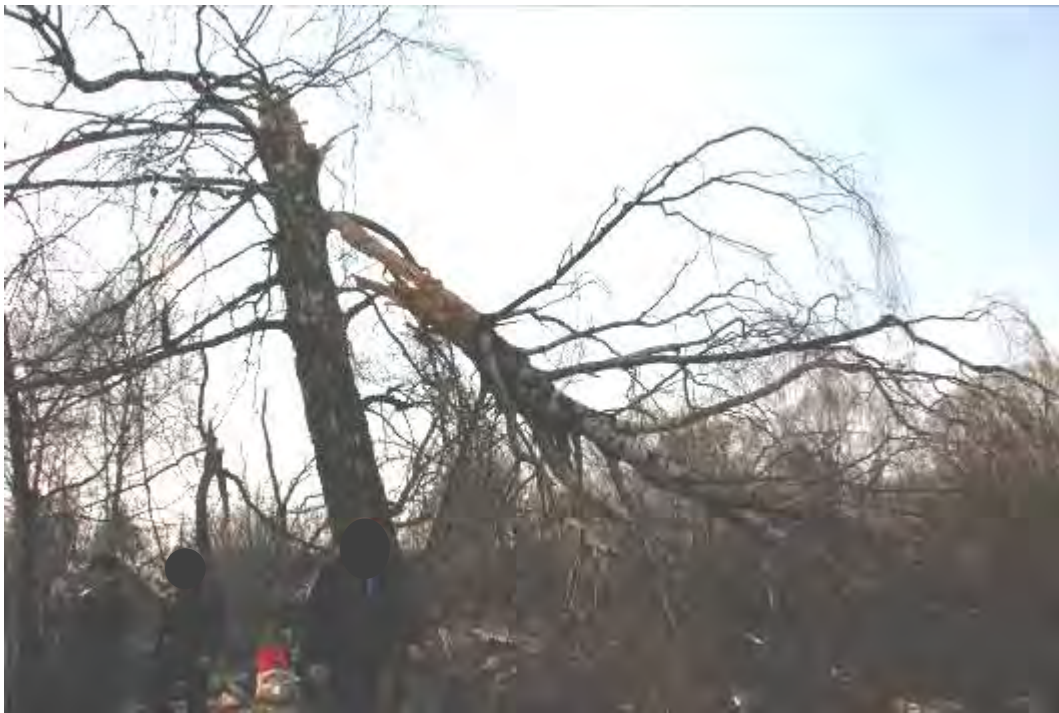
The collision lead to a simultaneous loss of leaktightness in all three hydraulic systems - the hydraulic pipes supplying the RP-55 control gear of the left aileron were torn apart. The disruption of the hydraulic lines was accompanied by the loss of hydraulic fluid from the systems and the pressure drop in the all of them.

Fig. 4. The birch tree, the collision with which resulted in the tearing away a part of the left wing

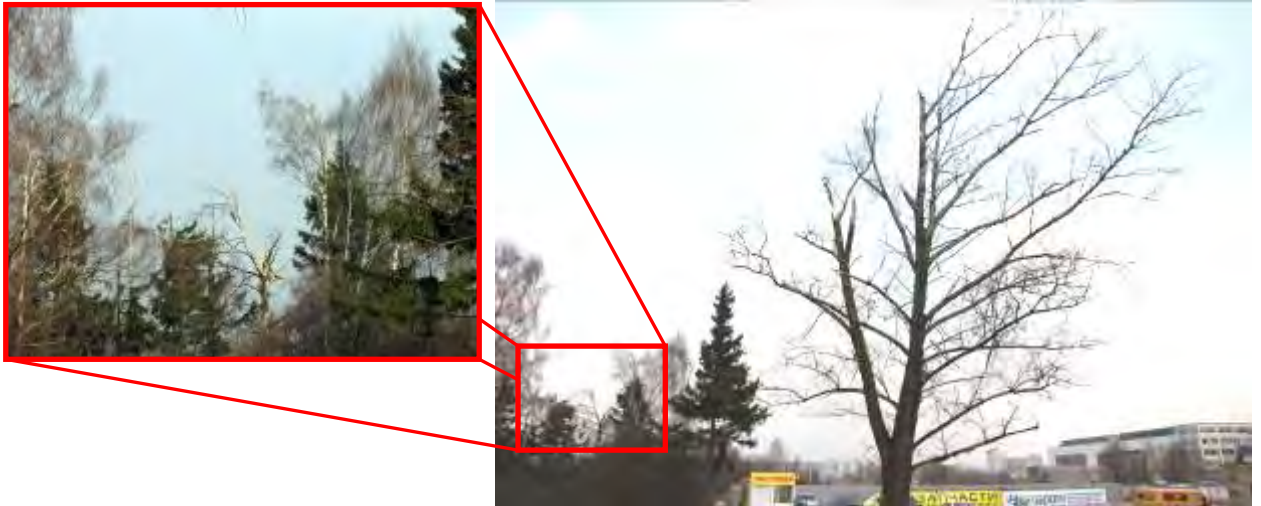
After having flown another 200 m, the aircraft collided with tree branches of a diameter up to 20 cm which caused further dents in the leading edges, damaged skin panels, and tore away the left part of the stabilizer together with the left elevator.

Fig. 5. The trees that inflicted further damage to the wing's leading edges and tore away the left tailplane.

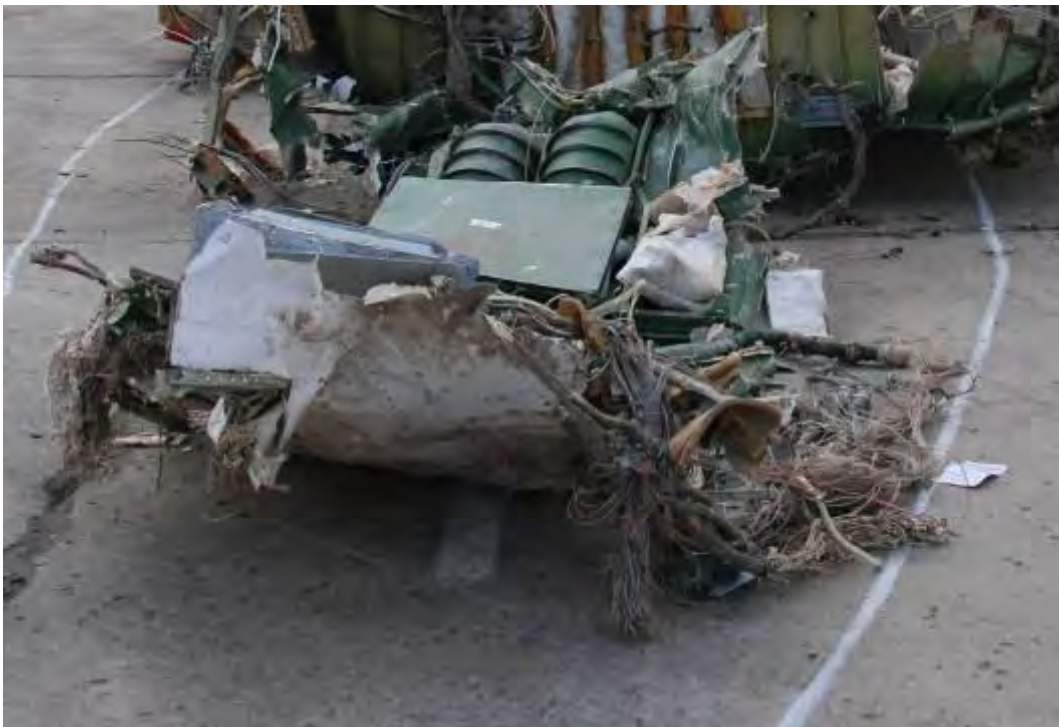
- a) The crushed front lower section from the nose to frame 13 (fig. 7). The whole front section of the aircraft, including the radar cover, cockpit and equipment found in this section of the fuselage were crushed and torn into small fragments. Casings and glass elements of onboard instruments found in the cockpit were extensively dented and broken. Most of them remained attached to the crushed fragments of instrument panels.

Fig. 7. The remnants of the aircraft's front section

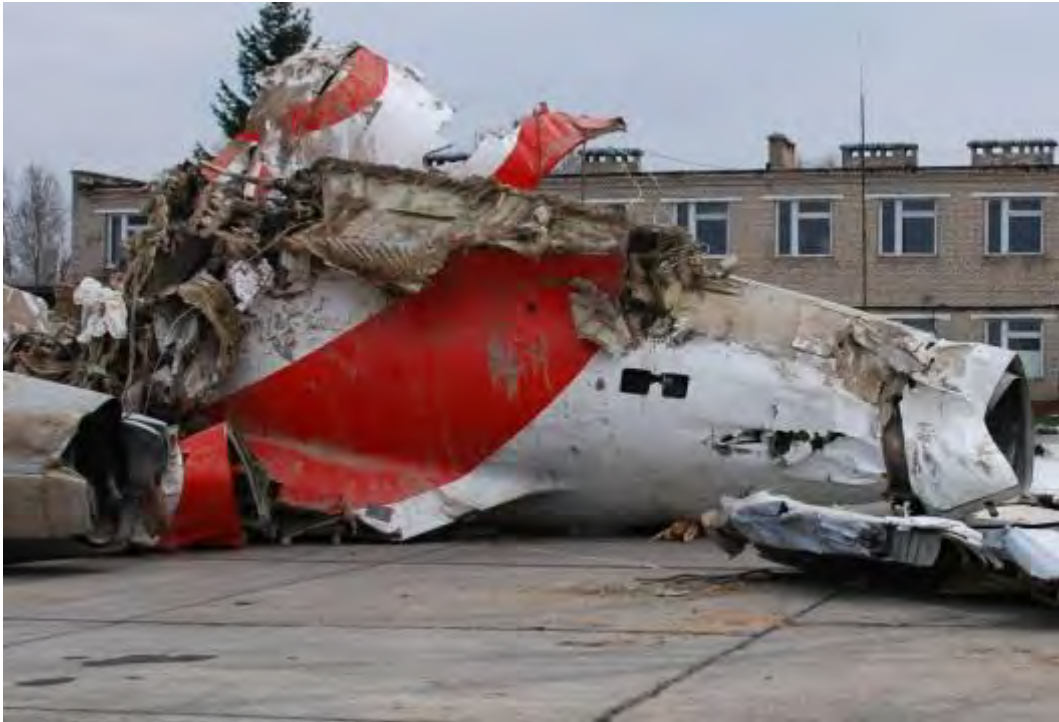
engine 1 cowl was torn away at its root from the fuselage. The engine 3 cowl was torn apart - its upper section remained with the tail part of the fuselage.

Fig. 12. The tail part of the fuselage

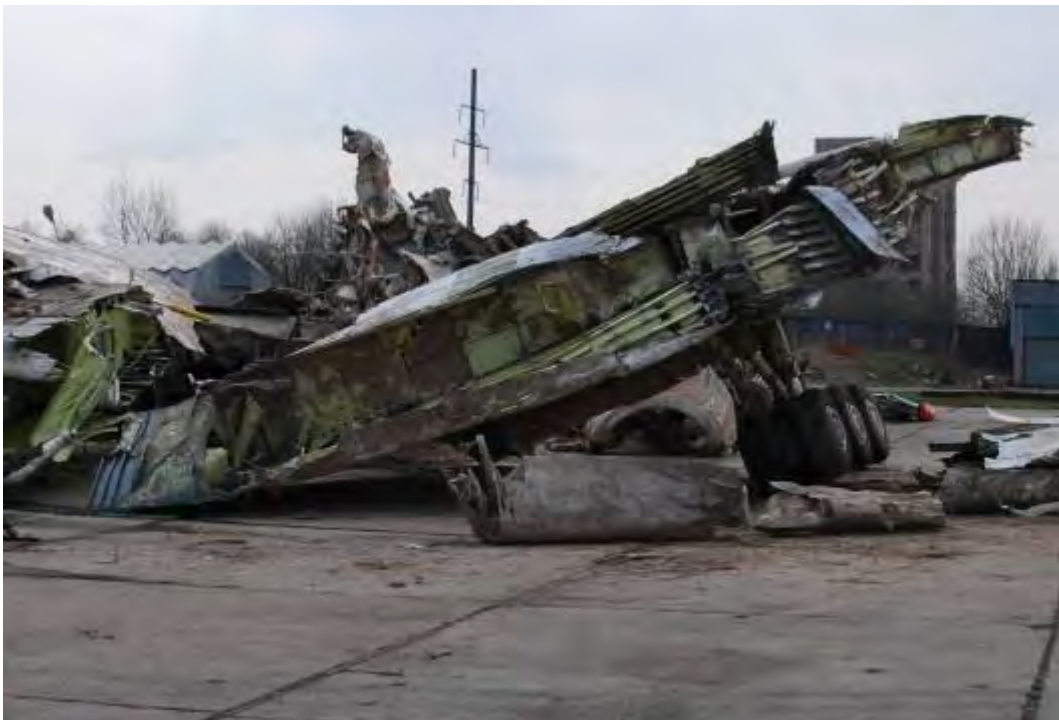
Fig. 16. The torn leading edge of the left wing
